SYSTEM FAILURE CASE STUDIES

DECEMBER 2011 VOLUME 5 ISSUE 12

Porthole to Failure

Mobile Offshore Drilling Unit Capsizes in Severe Storm; 84 Dead.

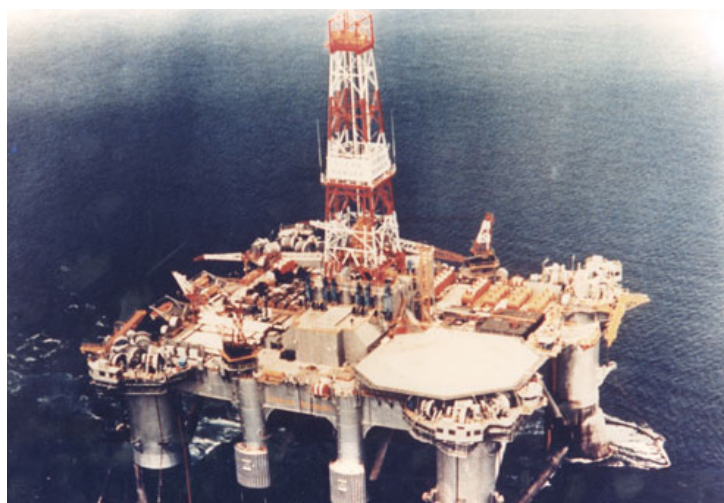
Figure 1: The *Ocean Ranger* was the world's largest and most advanced drilling platform of its day.

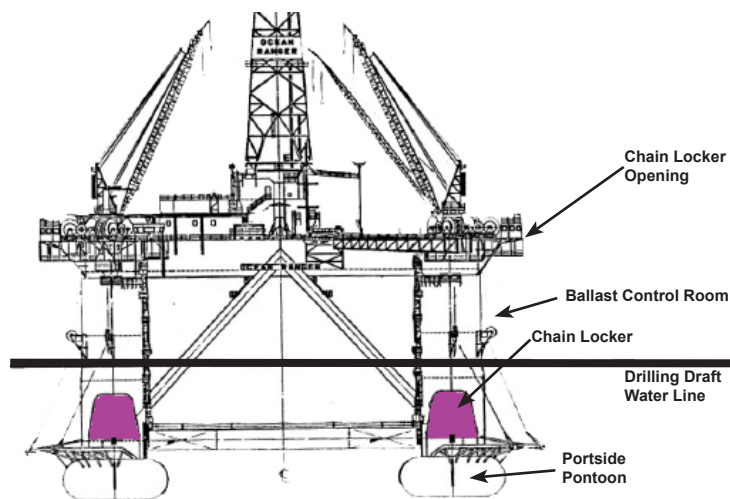
Figure 2: Ocean Ranger drilling platform and support structure

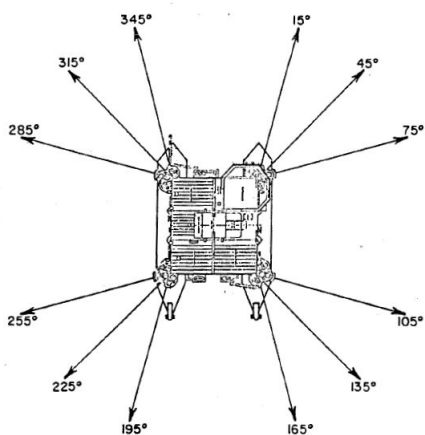
Figure 3: Top view showing the 12 anchors that steadied the oil rig over the wellhead.
